Manhole Inspection Summary

Manhole # S25I__021MH

Insp Date: **4/1/09 6:58 AM**

Location Address: **103 Mt Clare**

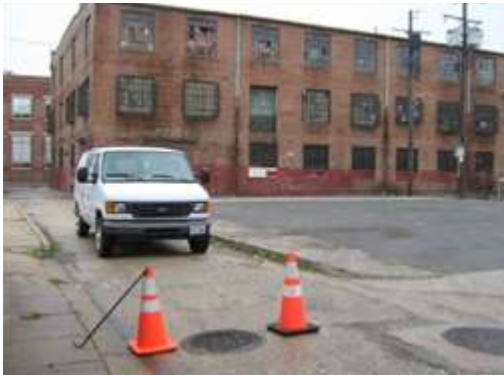
Location View

103 Mt Clare

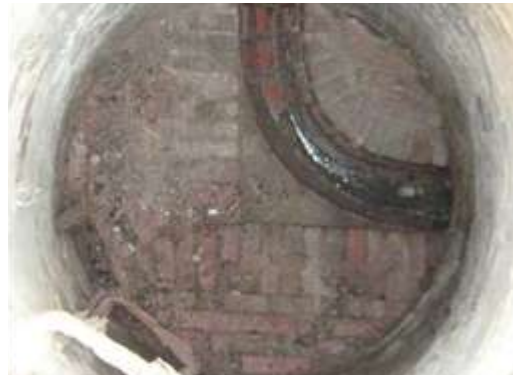
Top View

Condition: ☐ Sound ☐ Cracked ☐ Root Intrusion ☐ Loose Brick ☒ **Deteriorated**

Infiltration: ☐ None ☒ **Joint** ☐ Cracks ☒ **Mortar** ☐ Roots ☐ Wall

Infiltration: ☐ None ☐ Joint ☐ Cracks ☐ Mortar ☐ Roots ☒ **Wall**

Steps Count: **4** Missing: **1** ☒ **Corroded**
